**Composite Panel Failure Analysis  
and Improvement Plan**

**U.S. Army Belvoir Research, Development  
and Engineering Center  
Fort Belvoir, VA 22060-5606**

**Martin Marietta Technologies, Inc.  
Martin Marietta Laboratories  
1450 South Rolling Road  
Baltimore, MD 21227-3848**

December 21, 1993

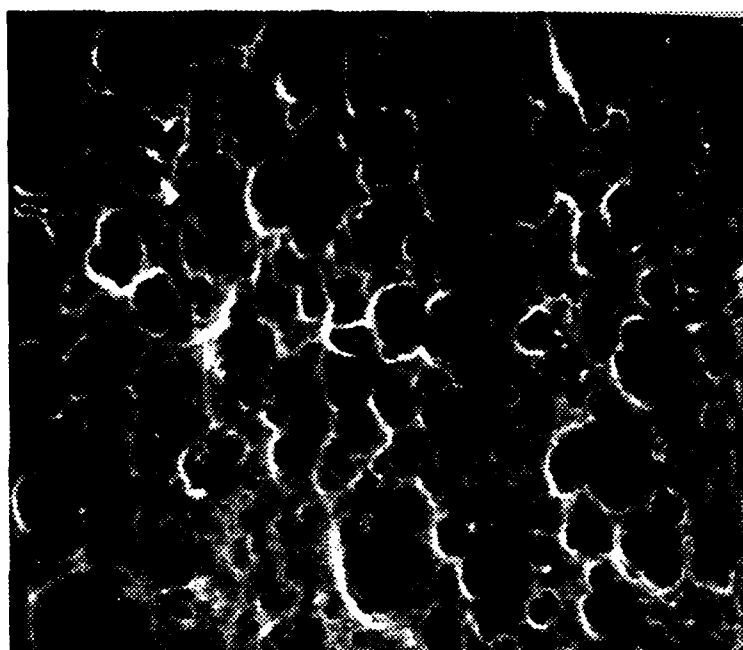
The electron micrographs of the surface analysis #1 specimen show a clean, complete break between the metal and adhesive side of the failure, Figures 19 and 20. In this case the metal side of the specimen shows distinct surface features, that are clearly replicated in the adhesive on the opposite side. The surface morphology is typical of an acid etched aluminum, with a pockmarked appearance. This surface is not typical of aerospace bonding practice, for it lacks the porous oxide layer that is receptive to adhesive infiltration and interlocking. This surface treatment should provide somewhat inferior dry bond strengths, but significantly reduced performance under high humidity conditions.

Figure 19. Electron micrograph of the metal surface of short beam specimen #2 in the slick-off region. The "lunar landscape" is typical of an acid-etched aluminum surface.

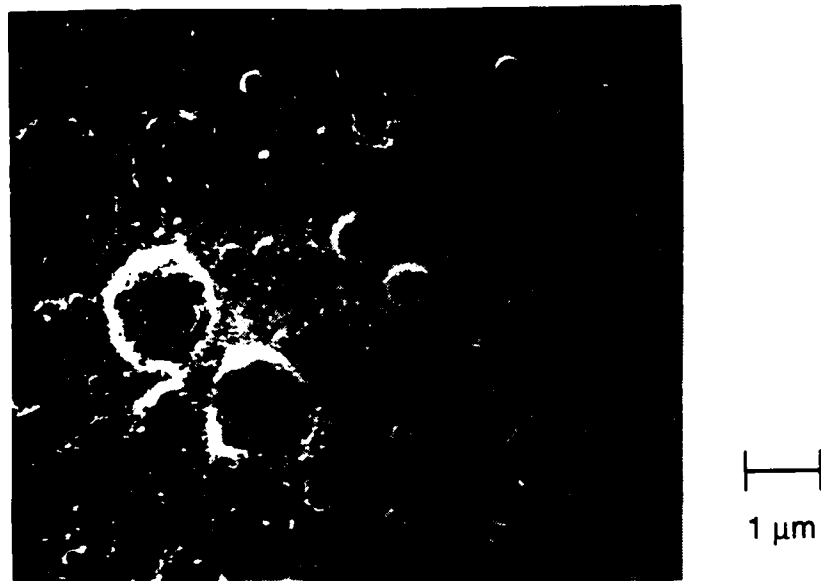
Figure 25. Electron micrograph of the skin surface on the type I panel in a slick-off region at the edge (part of the tail from the central slick-off). The etched surfaced appears to be coated with a light layer of adhesive.

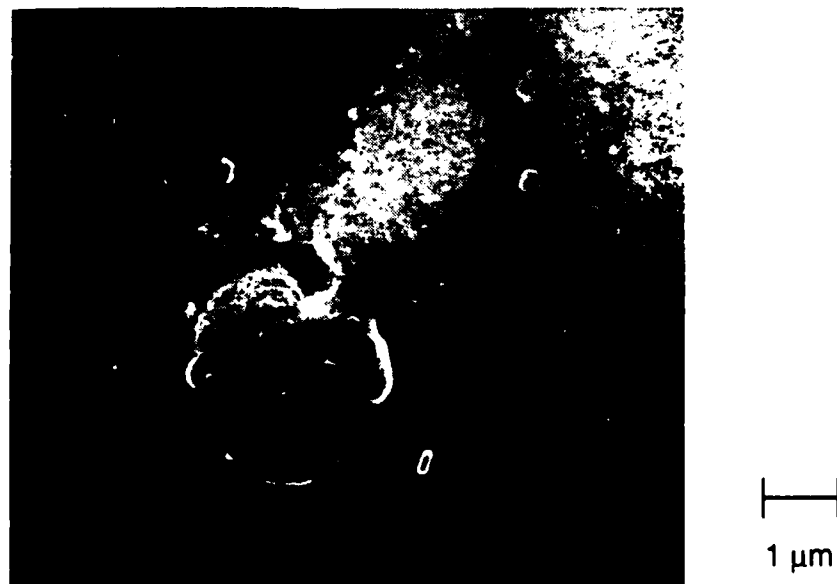
Figure 26. Electron micrograph of the adhesive mating surface of the edge of the type I panel. This surface lacks the sharp-edged features of true replicas, indicating a cohesive rather than interfacial failure. DSC of adhesive material taken from this region indicate lack of cure, which would explain a cohesive failure.

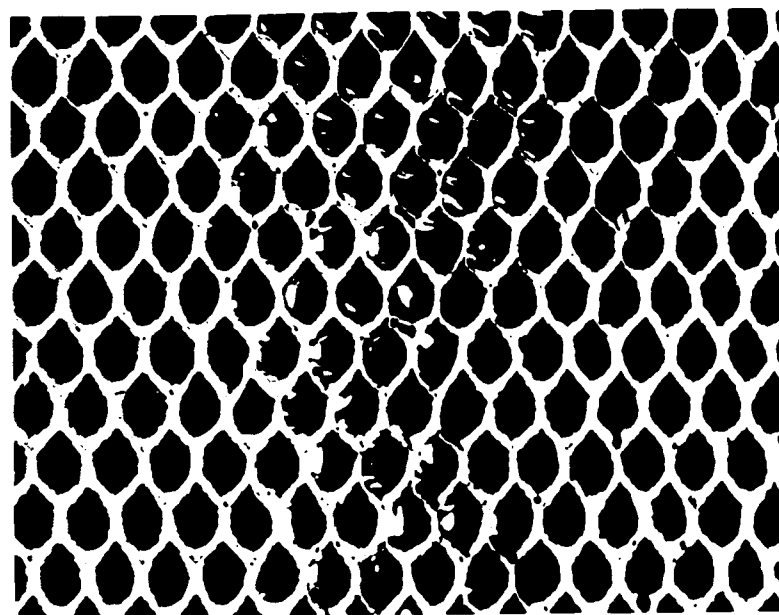
Contrast the surfaces of short beam sample #6 shown in Figures 35 and 36 with those of the test specimen. A band of core pull-off cells can be seen in the center of the macrographs, but even in the relatively well bonded regions at either side the amount of adhesive remaining on the core is much less than that seen above. In addition, the areas on the skin where the core pulled off the adhesive show much more remaining adhesive; the support fabric clearly seen in the test specimen skin photos is completely obscured by an adhesive layer here. This specimen had a backside skin failure and showed core buckling. Similar macrographs from a v-notch, top skin failure show exactly the same features, Figures 37 and 38. These features are not directly related to the cure schedule used, but must reflect another deficiency in bonding practice, namely inadequate pressure to force the core into the adhesive..

Figure 35. Macrograph of the core side of short beam sample #6. Relatively little adhesive remains on the core.

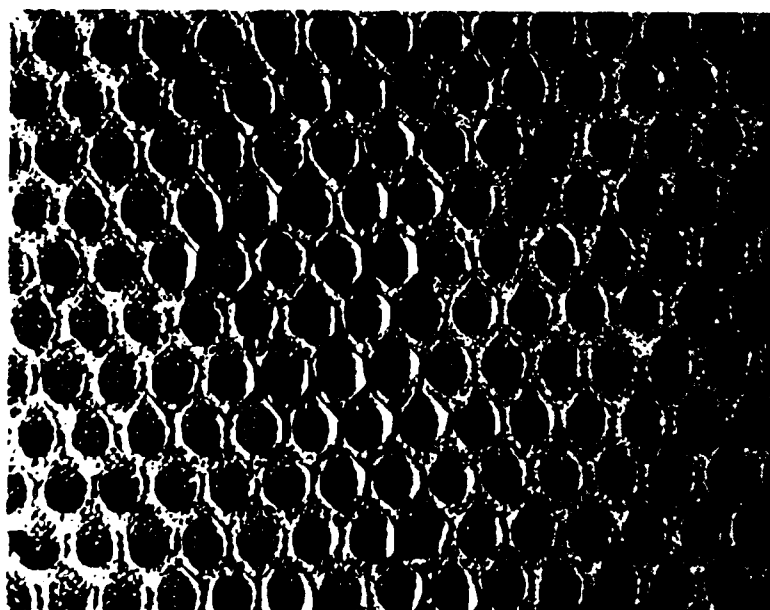
The other problem related to pressure was seen in the general core to skin bonds. None of the core seemed to be sufficiently pressed into the adhesive to make normal fillets. As Figure 36 shows, the average panel core to skin bond showed considerably more adhesive underneath the honeycomb, and less in the fillet, than would be expected using standard methods. This would significantly reduce the strength of this bond, and lead to the marginal failures observed in the short beam testing. It appears that the overall pressure used to bond the mats was insufficient. Although the FPS para. 3.13 states that 35 psi should be applied to the platens, the bondments indicate that the actual pressure was lower. This certainly should be checked in the future.

Figure 36. Macrograph of the skin side of the short beam sample #6. Adhesive still coats the support fibers under the core imprint.
